**Metal Technology
Limited System 4-20 and
System 5-20 aluminium
windows tested to the
requirements of
BS 7950:1997**

Prepared for:
Metal Technology
Steeple Road Industrial Estate
Steeple Road
Antrim
BT41 1AB

2 December 2008

Test report number 239807

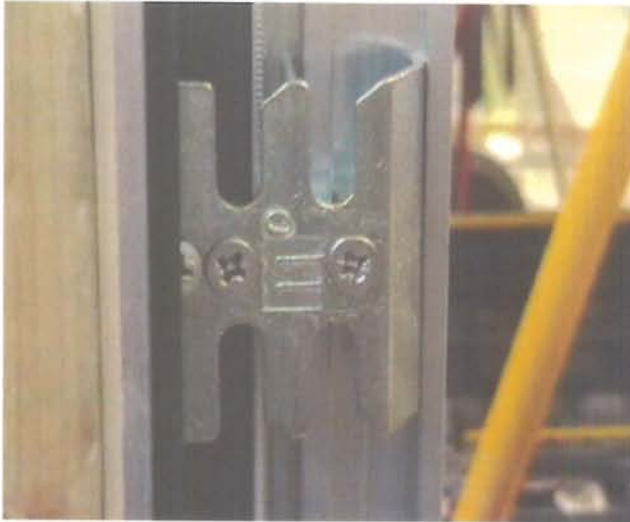
Figure 5 239807/2 – Keep before failure

Location	Case (From Table B1 in BS 7950:1997 ¹)	Parallel To Plane Load	Perpendicular To Plane Load	Observations
Top right corner/ security claw	1/5	At right angles to the edge (1 kN), then along the edge towards the opposite edge (1 kN).	3 kN	Load held. 15 mm permanent deflection
Top left corner	3	In the direction to disengage the nearest locking point (1 kN)	3 kN	Load not achieved. Keep failed and >150 mm deflection achieved. A further 1 kN was applied and load held.
		At right angles towards the opposite edge (1 kN)	3 kN	Load not achieved. Second keep failed (see Figures 5 and 6). Test halted.
Test stopped	It was evident that placing loads at the other load points would result in further locking points failing and entry being achieved.

Specimen 239807/5 was submitted for test A.6 (mechanical loading) due to the non conformity found during the initial test. The sample was identical to specimens 239807/1 and 239807/2 in size and construction, the only difference was the fitting of a keep strengthening plate, Part No 835. This plate was fitted to the top and bottom corner keeps.

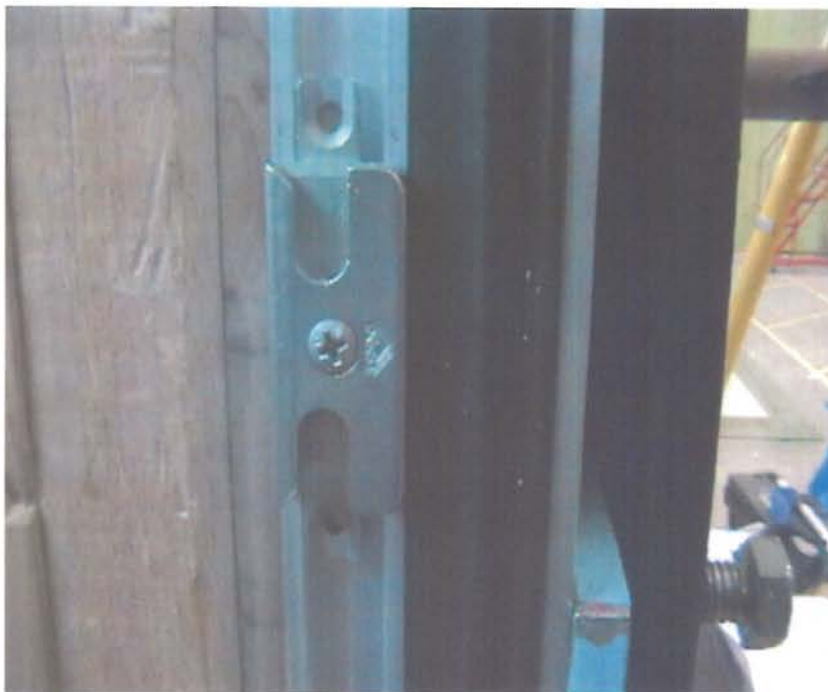
Figure 7 Keep before failure

Location	Case (From Table B1 in BS 7950:1997 ¹)	Parallel To Plane Load	Perpendicular To Plane Load	Observations
Top right corner/ security claw	3	In the direction to disengage the nearest locking point (1 kN)	3 kN	Load not achieved. Keep failed and >150 mm deflection achieved. A further 1 kN was applied and four keeps failed under load (see Figures 7 and 8). Entry gained.

Specimen 239807/6 was submitted for test A.6 (Mechanical Loading) due to the non conformity found during the initial test. The sample was identical to specimens 239807/3 and 239807/4 in size and construction, the only difference was the fitting of modified Roto security keeps (system Part No TTGEAR 992).
